**PHOTOGRAPHIC ANALYSIS VIEWPOINTS AND LOCATIONS**

PHOTOS TAKEN BY HILDERMAN THOMAS FRANK CRAM MAY 2006

**FIGURE 1B**

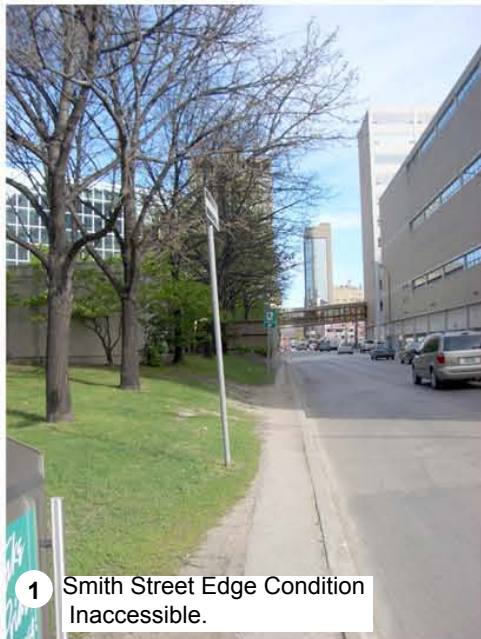
1 Smith Street Edge Condition Inaccessible.

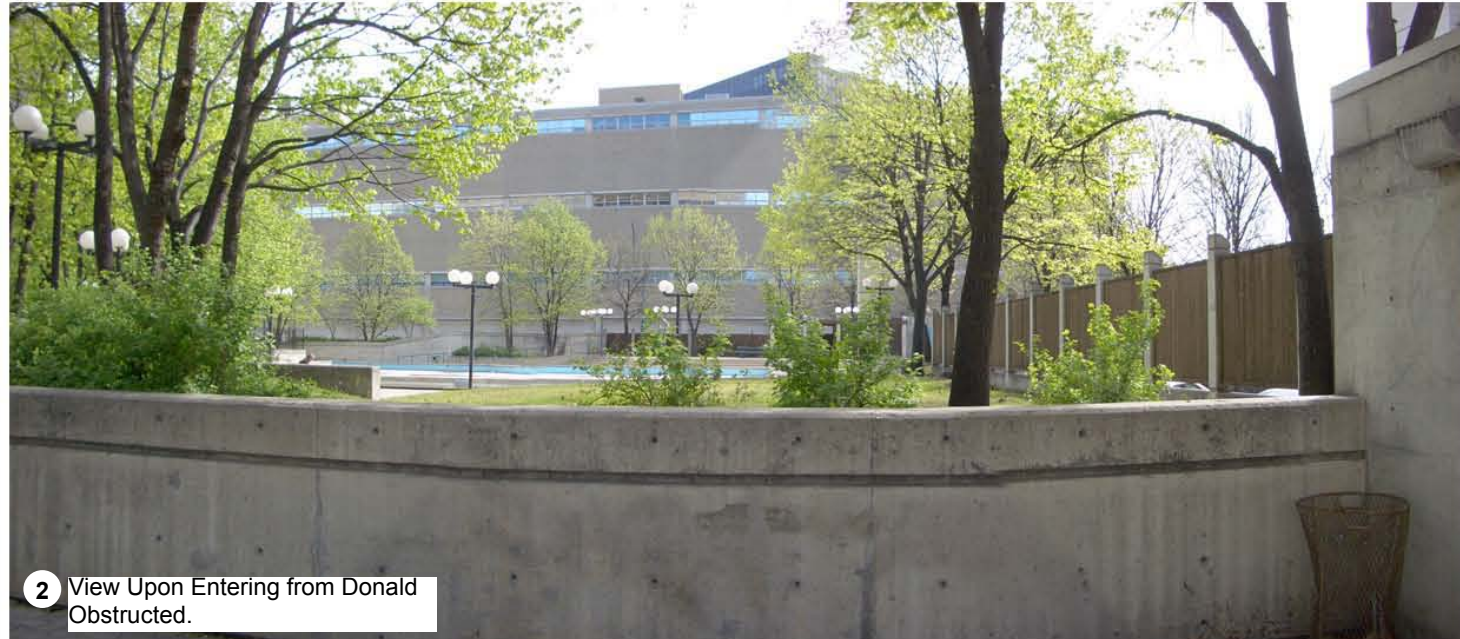
2 View Upon Entering from Donald Obstructed.

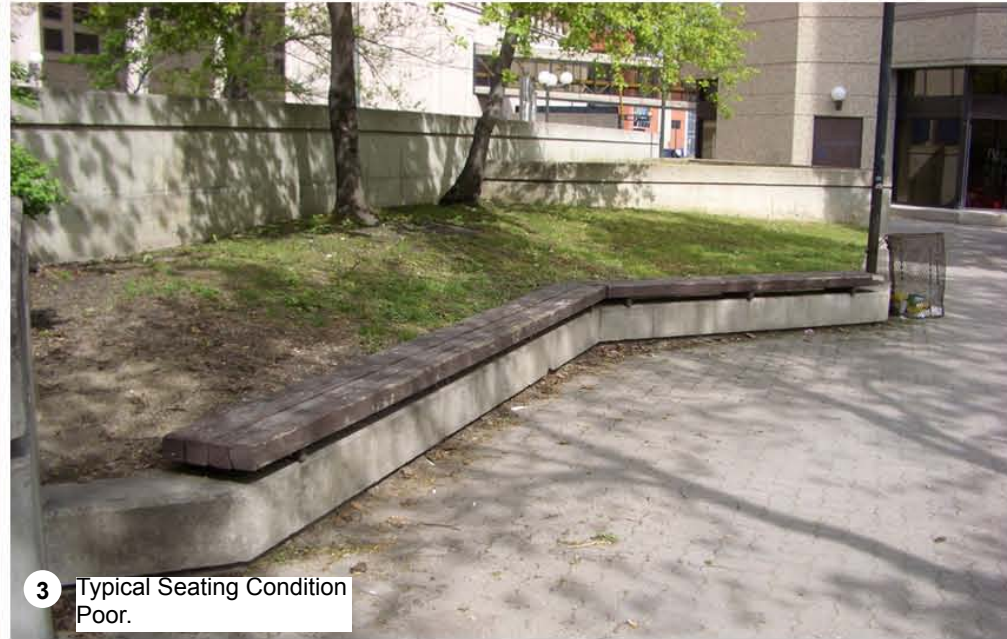
3 Typical Seating Condition Poor.

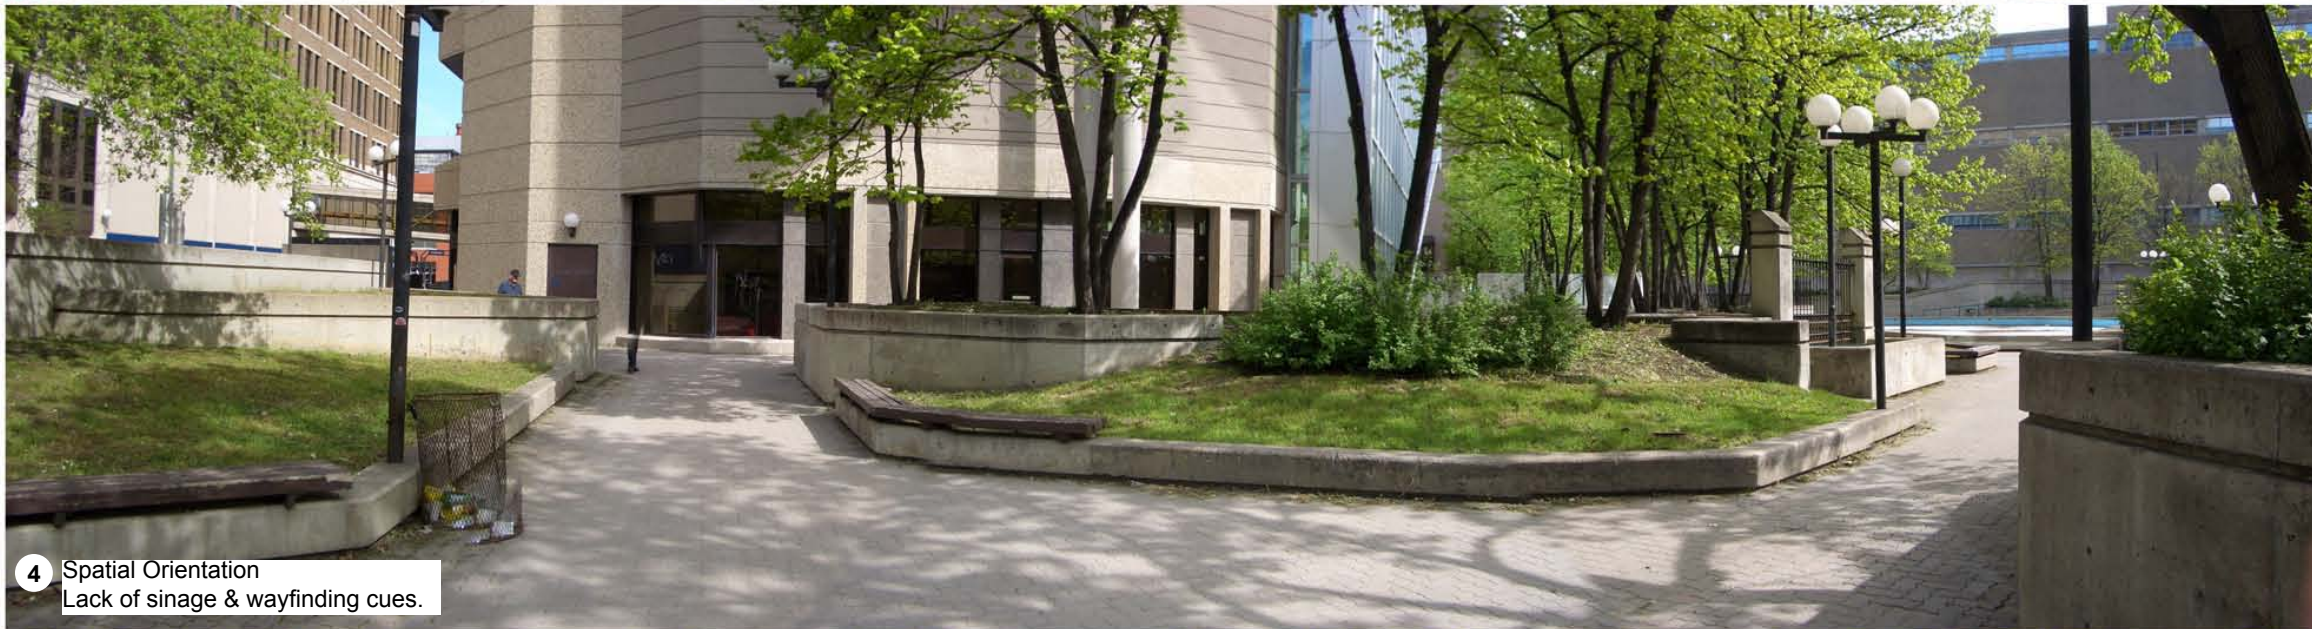
4 Spatial Orientation Lack of signage & wayfinding cues.

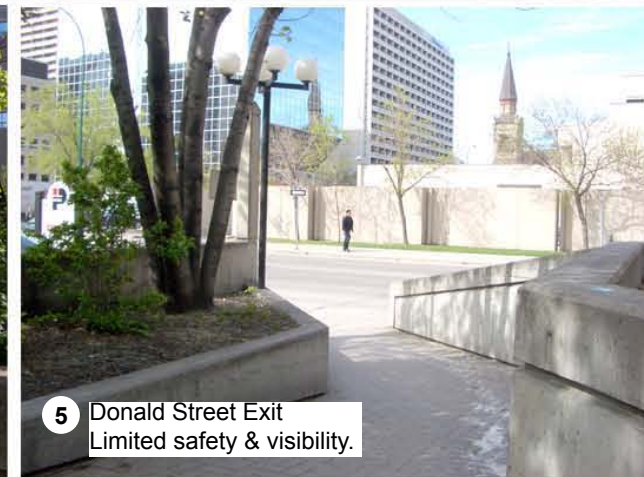
5 Donald Street Exit Limited safety & visibility.

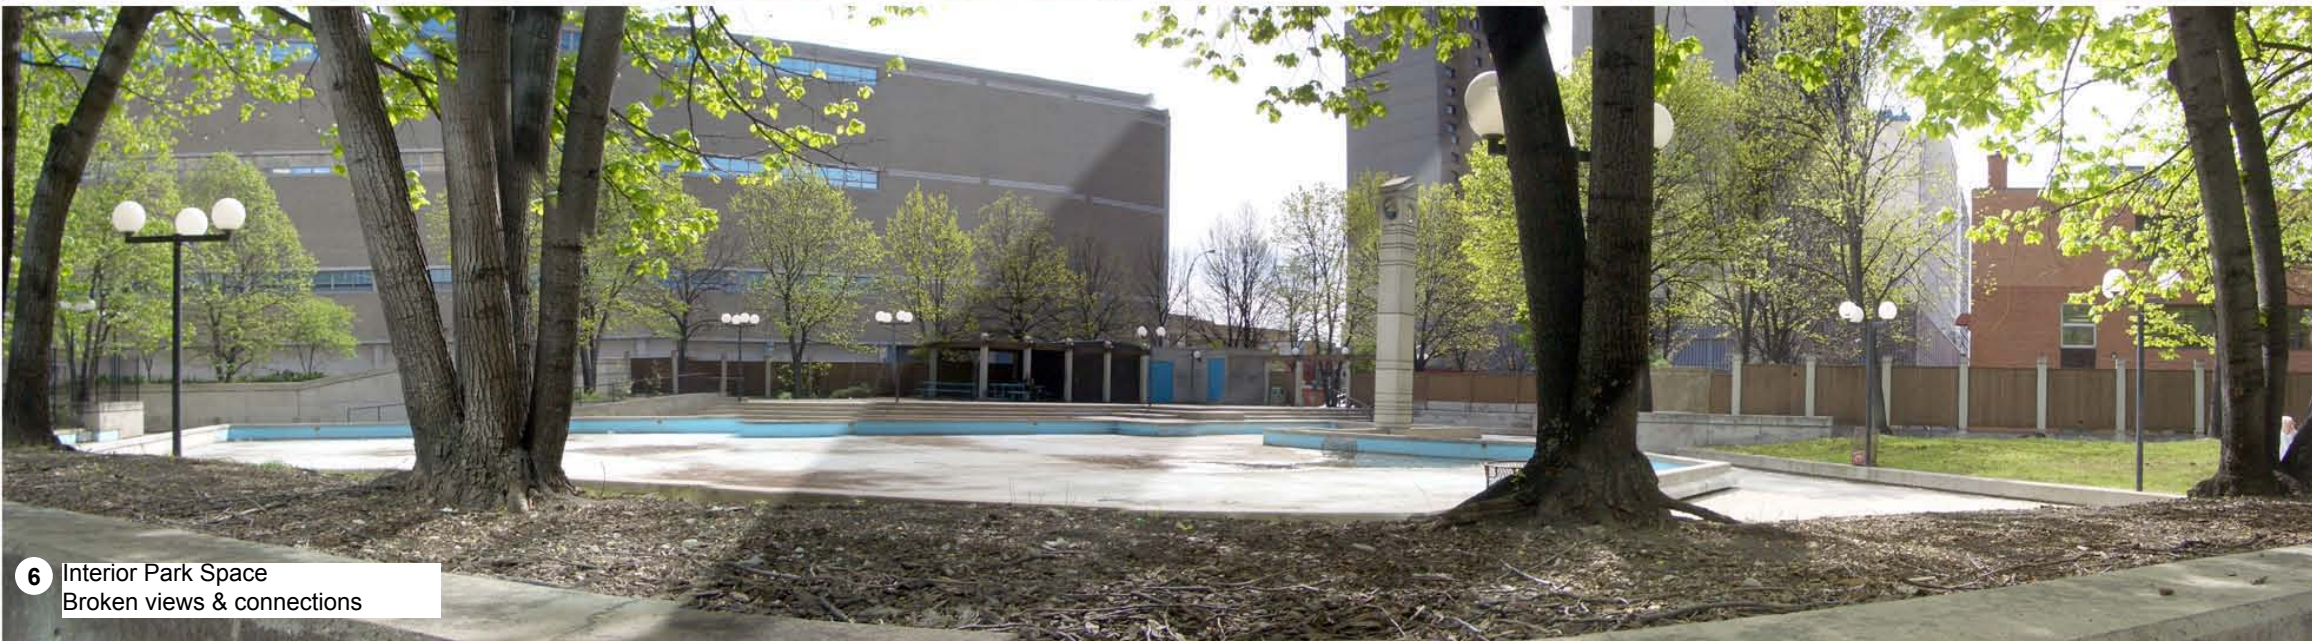
6 Interior Park Space Broken views & connections

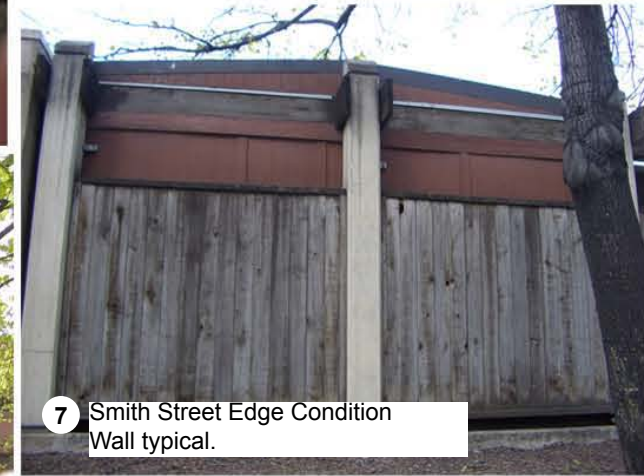
7 Smith Street Edge Condition Wall typical.

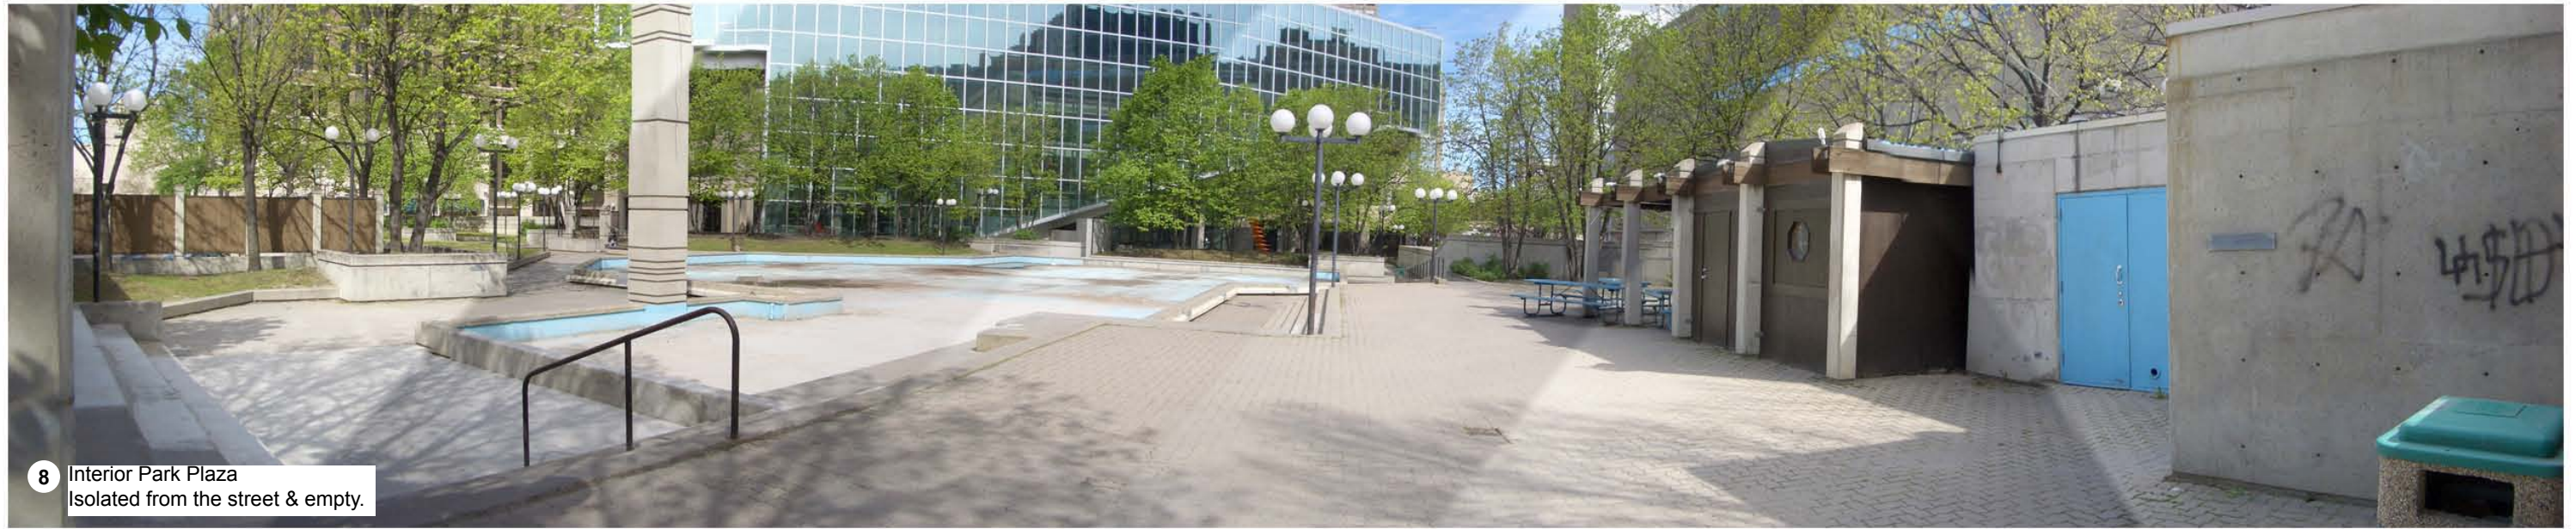
8 Interior Park Plaza  
Isolated from the street & empty.

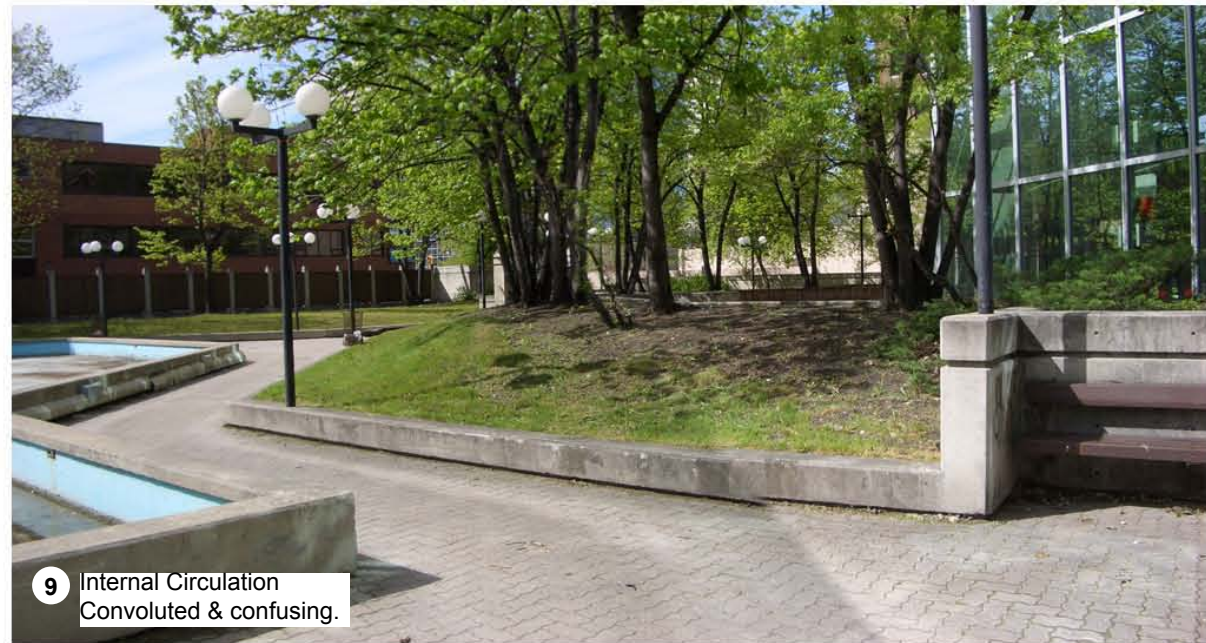
9 Internal Circulation  
Convoluted & confusing.

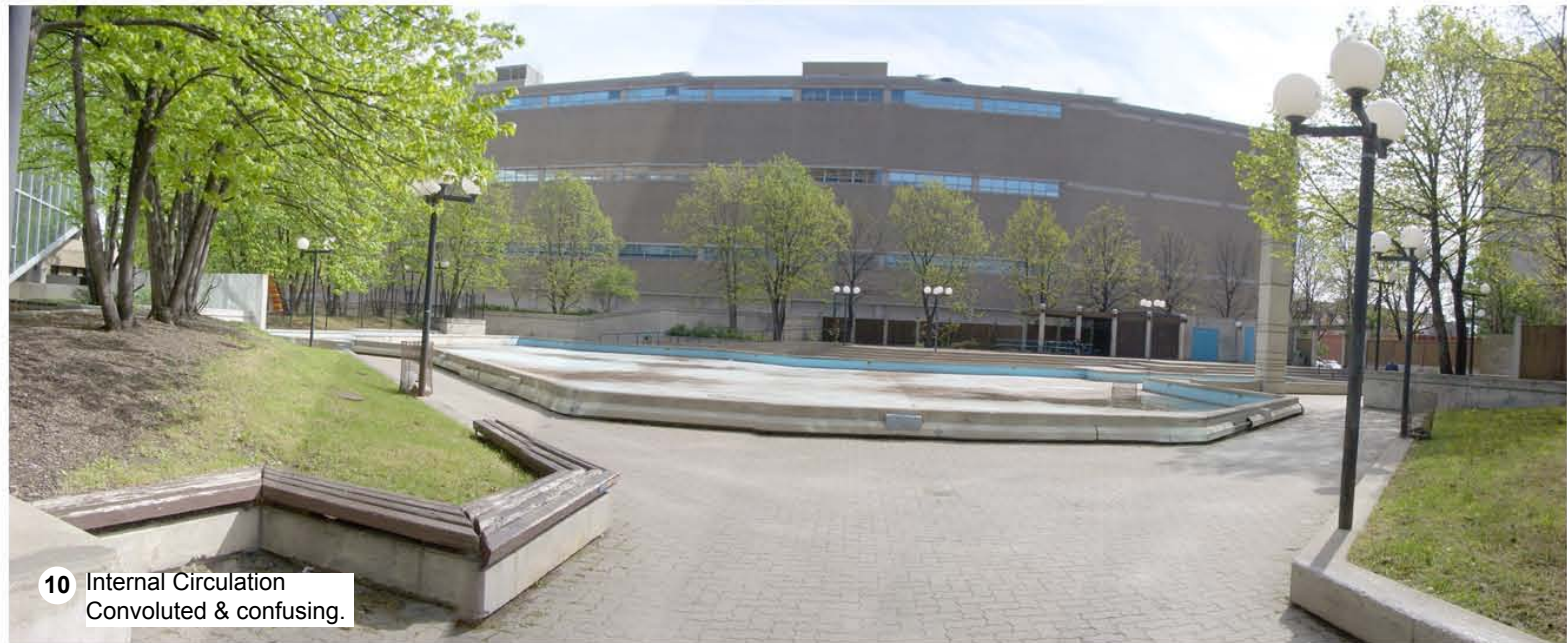
10 Internal Circulation  
Convoluted & confusing.

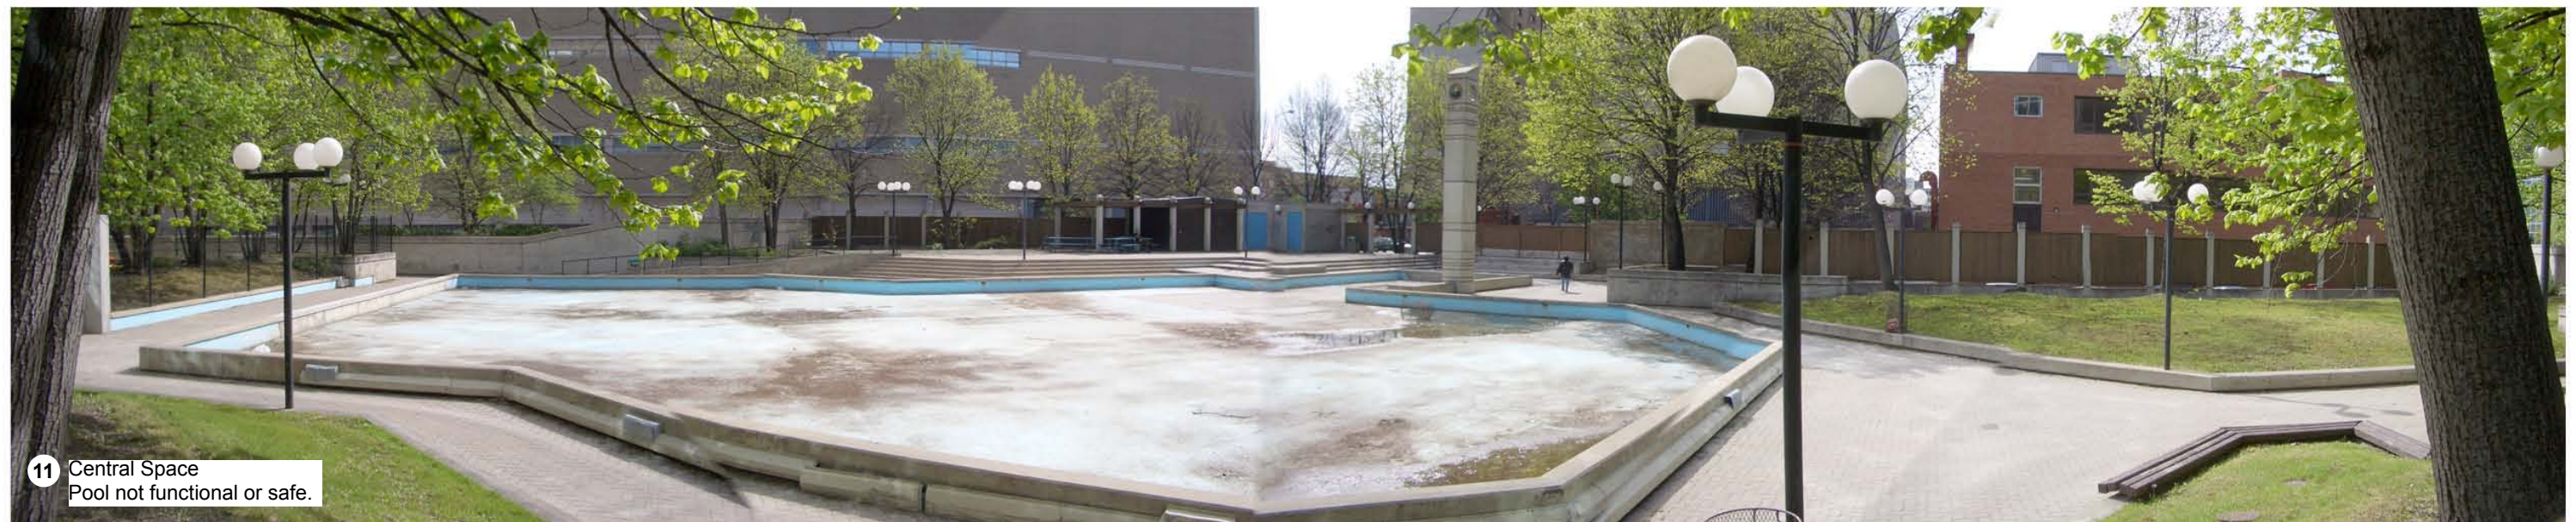
11 Central Space  
Pool not functional or safe.

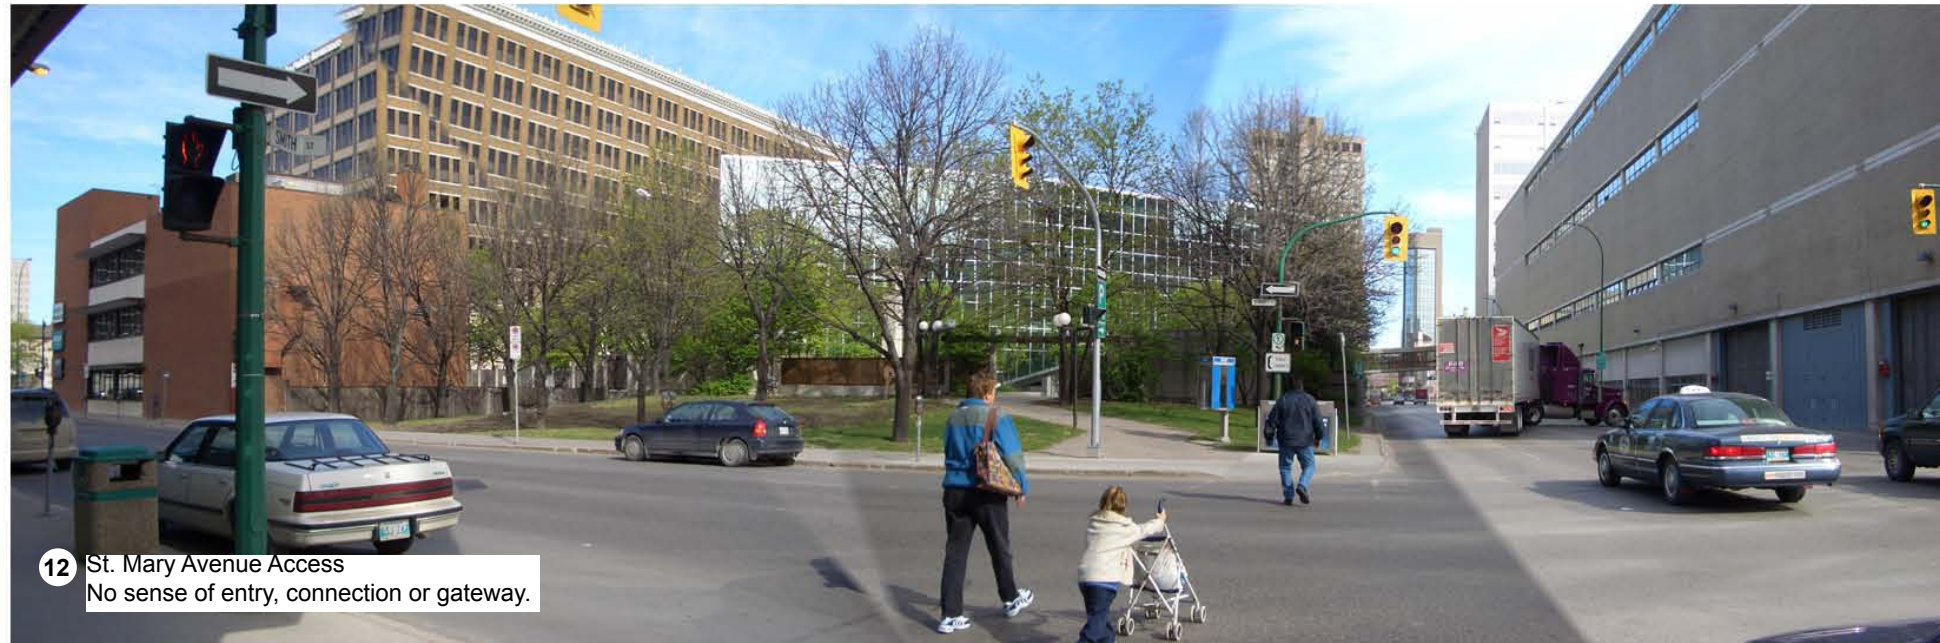
12 St. Mary Avenue Access  
No sense of entry, connection or gateway.

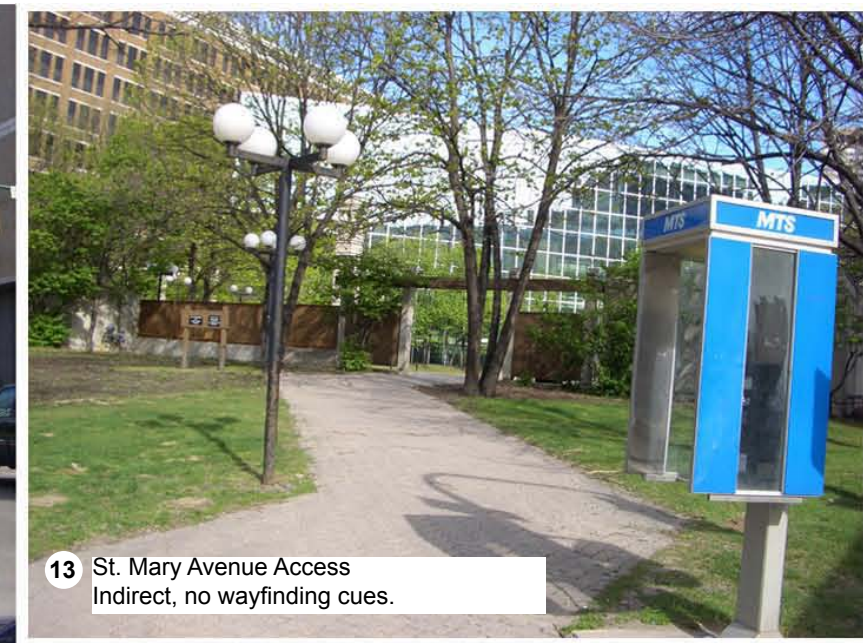
13 St. Mary Avenue Access  
Indirect, no wayfinding cues.

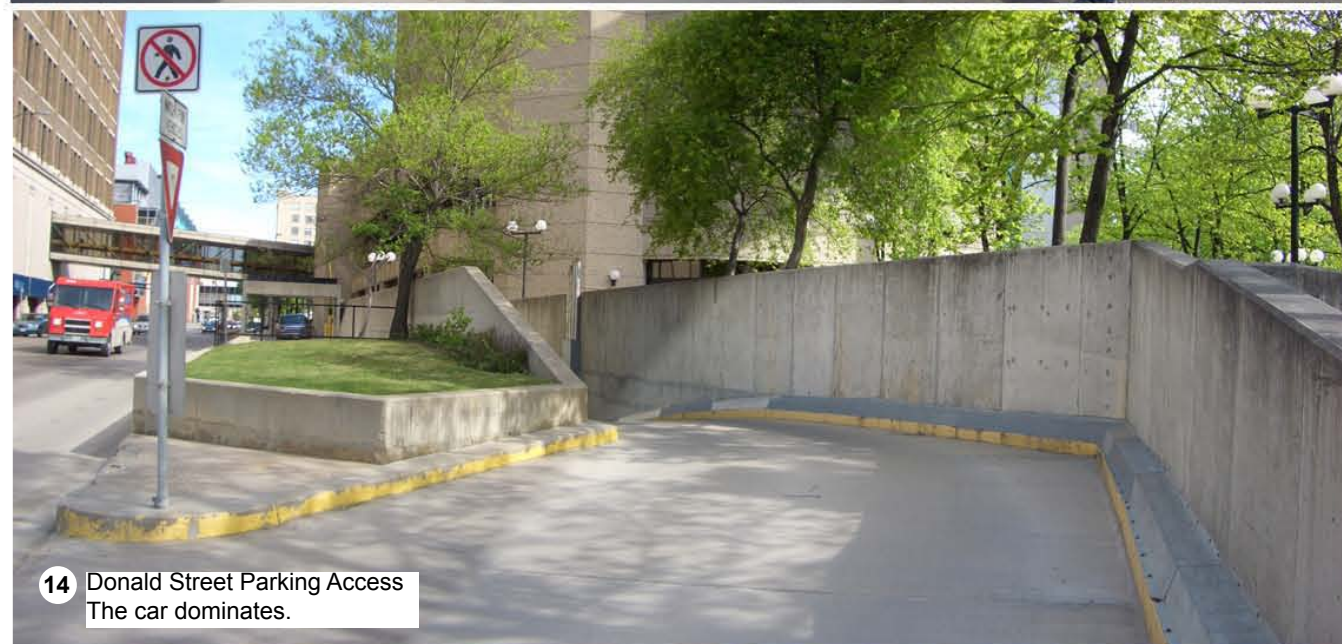
14 Donald Street Parking Access  
The car dominates.

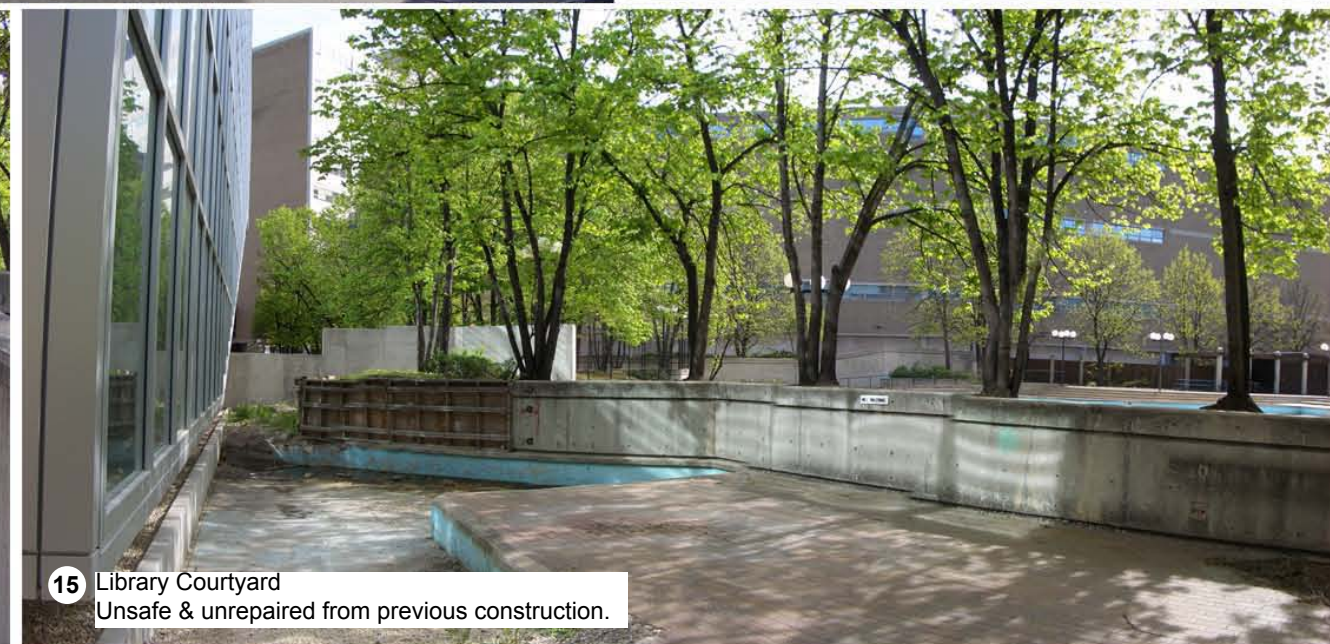
15 Library Courtyard  
Unsafe & unrepaired from previous construction.

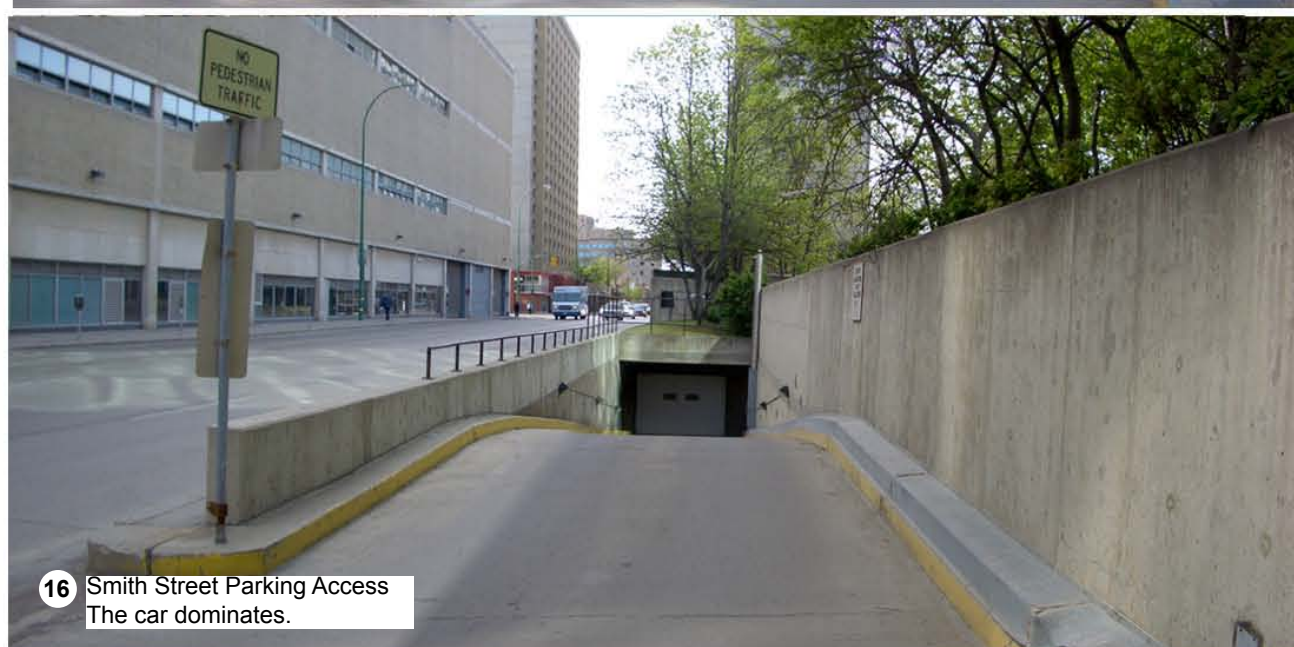
16 Smith Street Parking Access  
The car dominates.

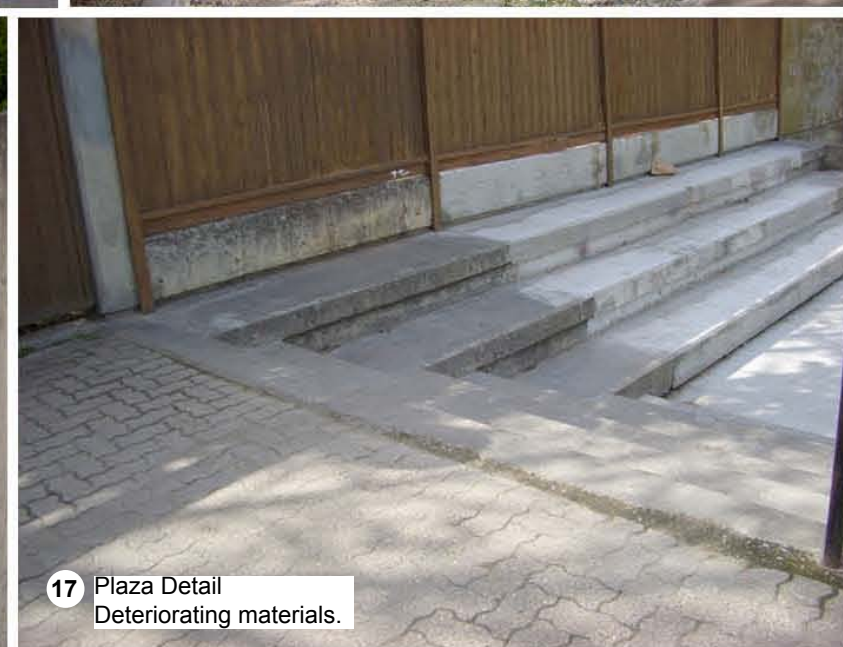
17 Plaza Detail  
Deteriorating materials.

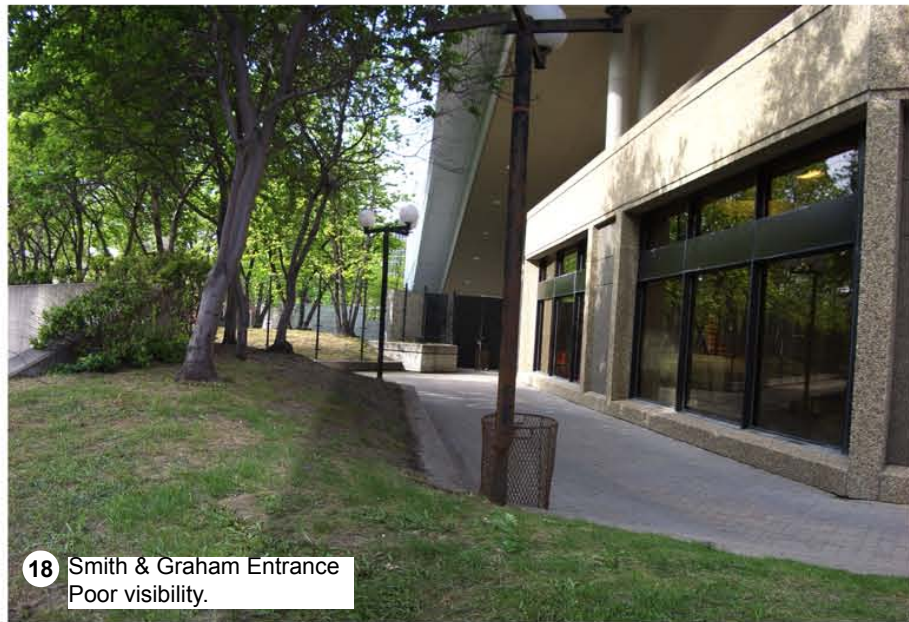
18 Smith & Graham Entrance  
Poor visibility.

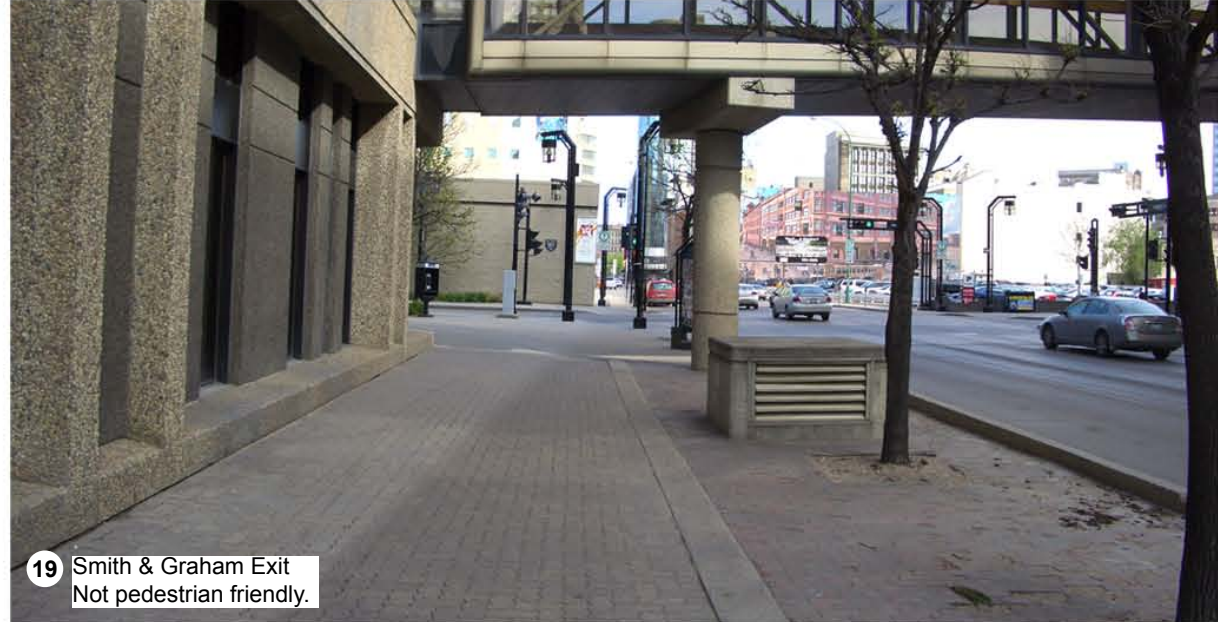
19 Smith & Graham Exit  
Not pedestrian friendly.

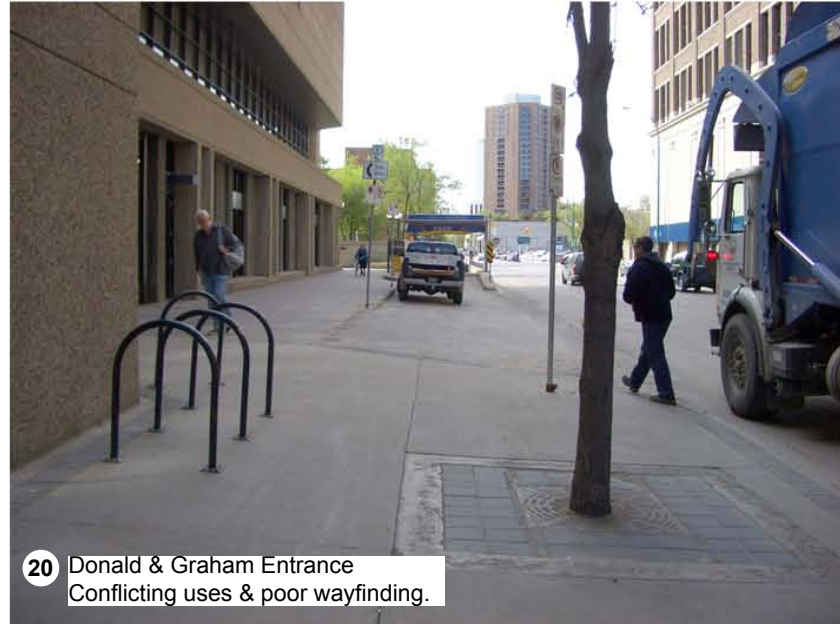
20 Donald & Graham Entrance  
Conflicting uses & poor wayfinding.

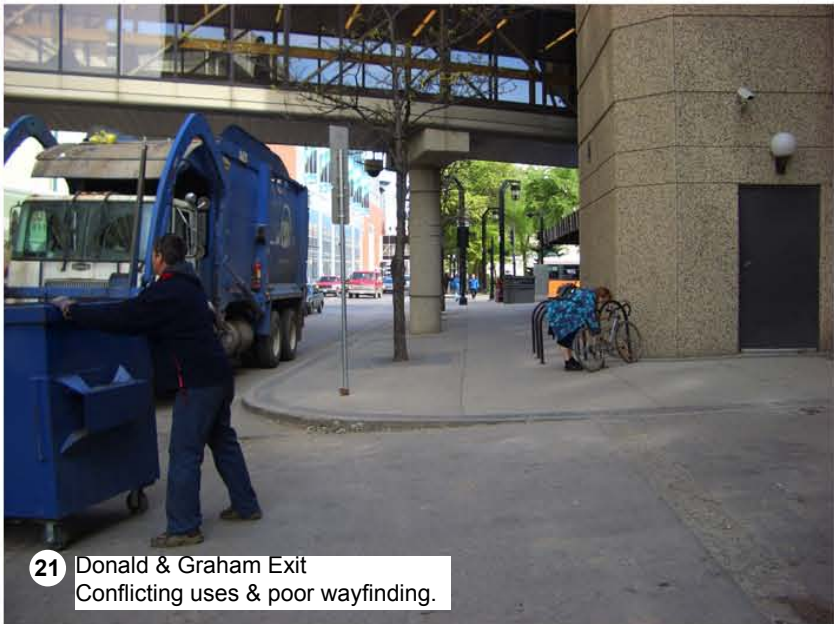
21 Donald & Graham Exit  
Conflicting uses & poor wayfinding.

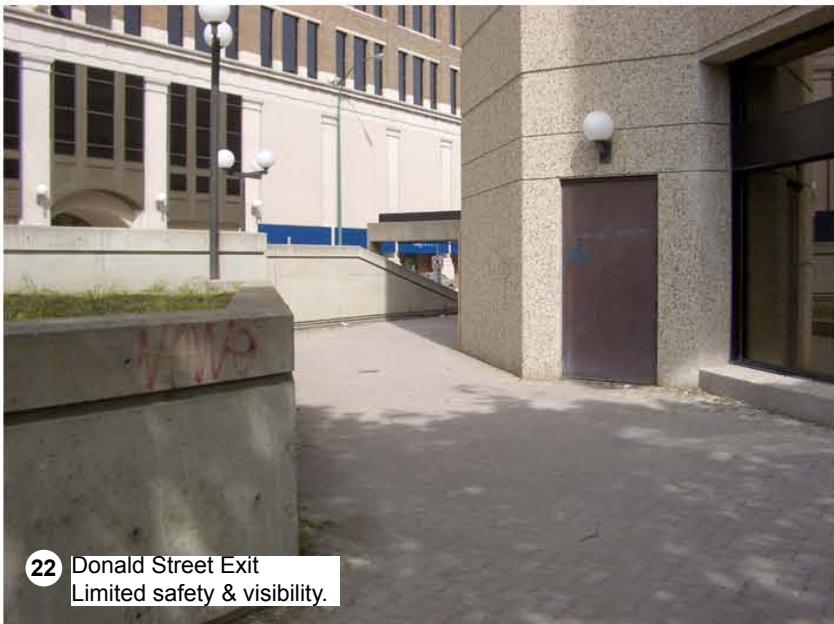
22 Donald Street Exit  
Limited safety & visibility.
